Manhole Inspection Summary

Manhole # S21A__047MH

Insp Date: **9/14/07 10:38 AM**

Location Address: **1600 HARLEM ST**

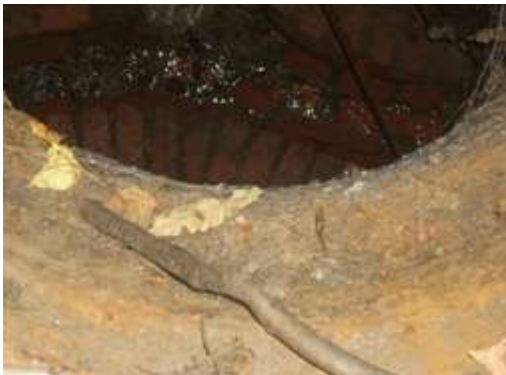
Defect 3

Frame Offset: **3** (in.) Condition: ☒ Sound ☐ Cracked ☐ Leaks

FRAME OFFSET

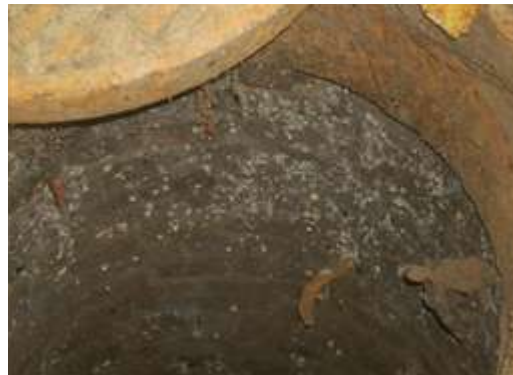
Defect 2

Surcharge ☒ **Evidence Of Surcharge** Depth: **5** (ft.) ☐ Active Surcharge Present

SURCHARGE EVIDENCE ON WALL

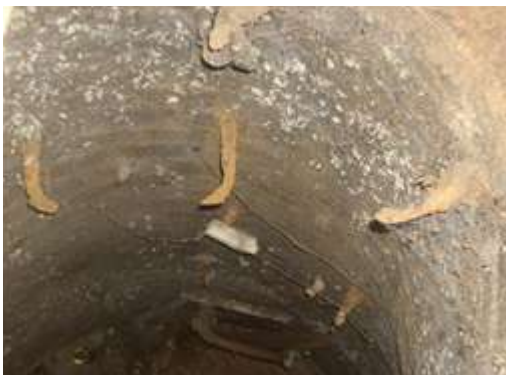
Defect 1

Steps Count: **3** Missing: **1** ☒ **Corroded**

MISSING AND CORRODED STEPS

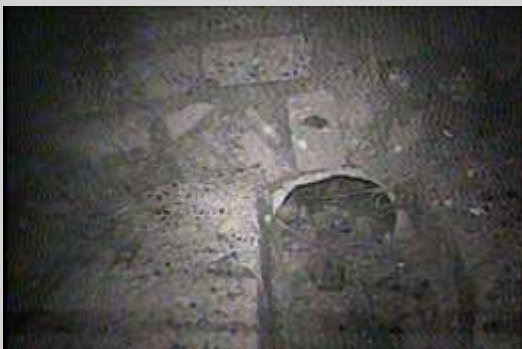
5 O'Clock Inflow

Pipe Height: **4.8** (in.) Rod and Bar (Angled)
Pipe Material: **Clay** ☐ Pipe Lined
Invert Depth: **8.42** (ft.) Flow Characteristics: **None**
Deposits: ☐ None ☐ Mud ☐ Sludge ☒ **Debris** ☐ Grease
Silt Depth: **5** (in.) Deposits Extent: **Heavy**
Infiltration: **None** Pipe Seal Cond: **Sound**

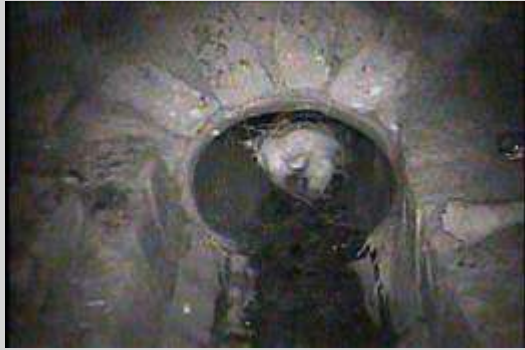
9 O'Clock Inflow

Deposits: ☐ None ☐ Mud ☐ Sludge ☒ **Debris** ☐ Grease

Silt Depth: **3** (in.) Deposits Extent: **Medium**
